Camp Kawartha Site and Facilities Master Plan

FINAL

DTAH Project Lead, Urban Design and Architecture

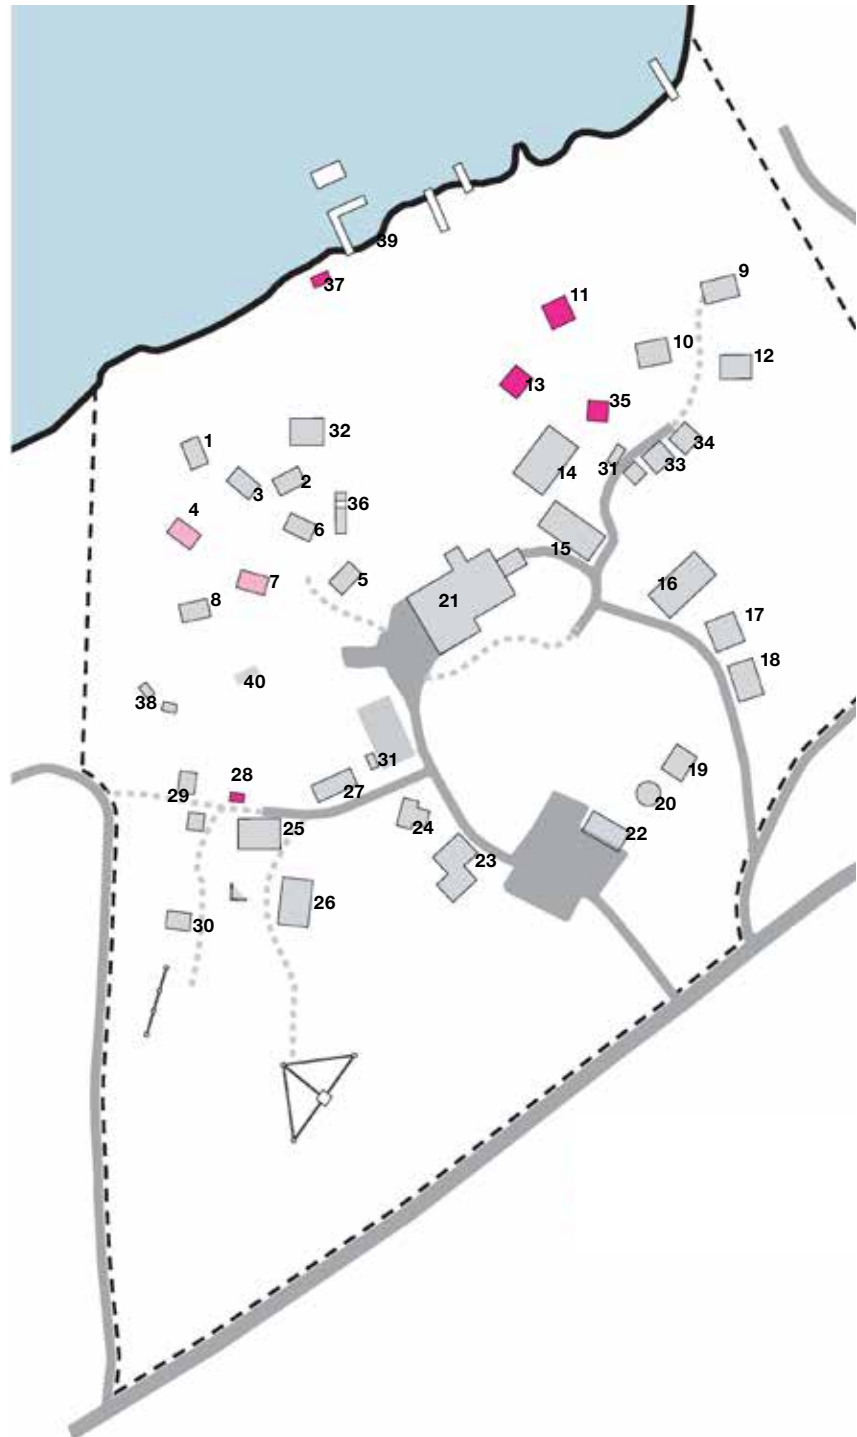
Buildings rendered in pink indicate significant structural concerns outlined in the condition assessment.

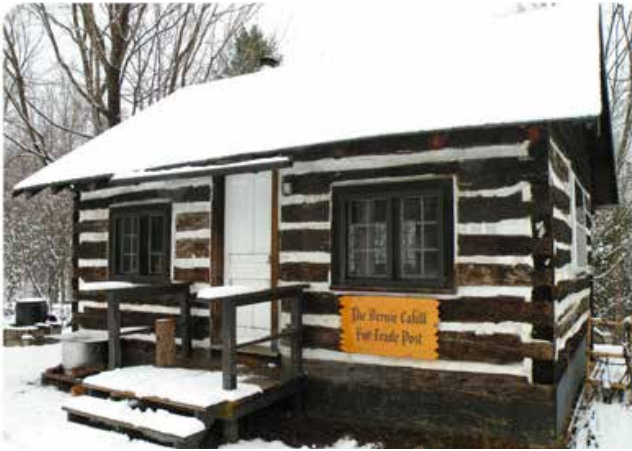
19. Trading Post

8 circuits 60 amps panel is installed fed from underground service. Portable electric heater. General lighting with ceiling fan. No outdoor ventilation, no humidity control, no drain. Humidity level is quite high at time of visit.

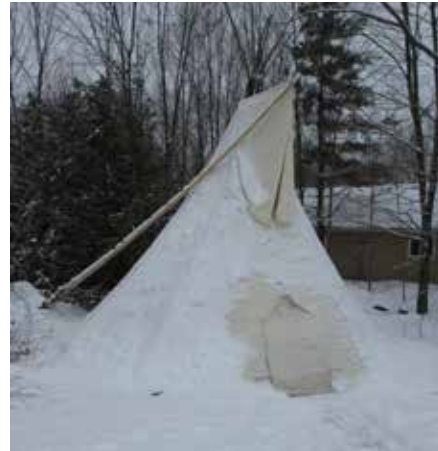
20. Teepee

60 amps underground electric services with a 24 circuit breaker panel.
 It was reported that the underground cable does not have sufficient coverage and running very close beneath the ground which can post an hazard.
 Smoke detector is installed.
 Log fire place is installed as means of heating.

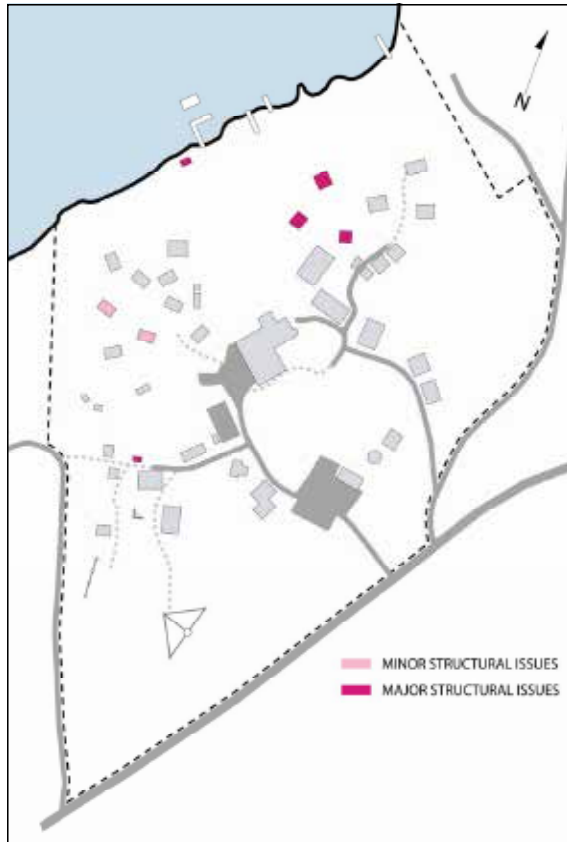
Structural Issues

- which structures are in need of major or minor structural repairs

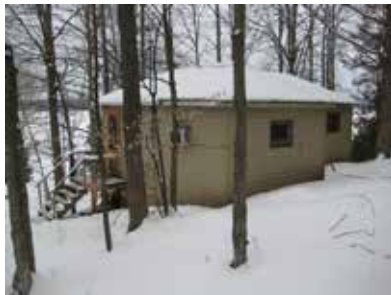
• Health Centre **POOR**

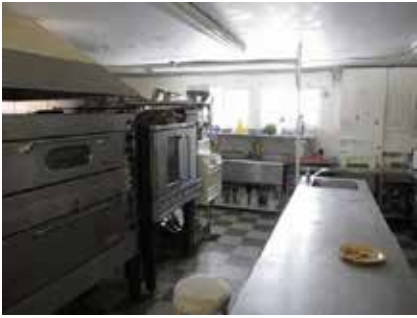
- Kitchen **FAIR/POOR**
