Camp Kawartha Site and Facilities Master Plan

FINAL

DTAH Project Lead, Urban Design and Architecture

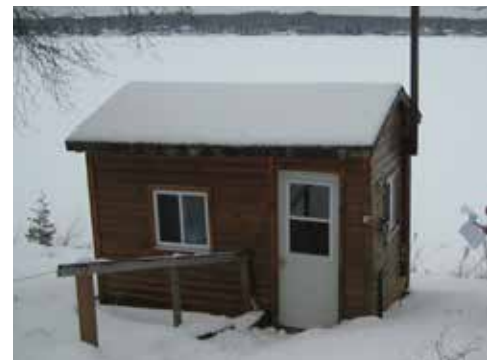
Pump House

These buildings provide infrastructure to the site, and are mostly in good condition with the exception of the pump house which should be carefully reviewed or replaced sooner than later.

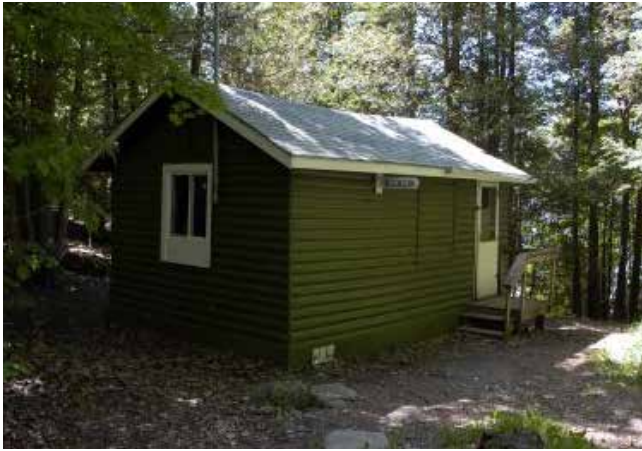
1. Algonquin Cabin

This cabin has recently upgraded structure, insulation, electrical services and interior finishes. Well insulated walls, roof and floor (+/- R20). Plywood skirting has been removed. Floor insulation is now protected from below with plywood sheathing. New windows and a new door - door has been relocated to south gable end - this opens onto a new entrance porch. Original roof in poor condition. New, vented and insulated roof scheduled to be installed. This cabin contains personal storage boxes for users. Similar size and configuration as Huron, Iroquois, Ottawa. Painted wood siding in fair condition

Good Condition

Foundations: 6 - CMU piers on 18x18x3" concrete paver footings. Recommend reinforcing by installing additional pier and footing at mid span of centre 6x6 beam.

Floor: 2 - lines of 2x6 @ 16"c/c Floor Joists on 6x6 centre beam (short direction) and new 6x6 PT sill beams. Floor bouncy. Recommend reinforcing by installing new CMU pier and pad footing at mid-span of centre beam.

30 amps overhead electric services with a breaker panel. Electrical wiring is fairly new. No ventilation system. Electric Heat, Smoke detector and Fire extinguisher.

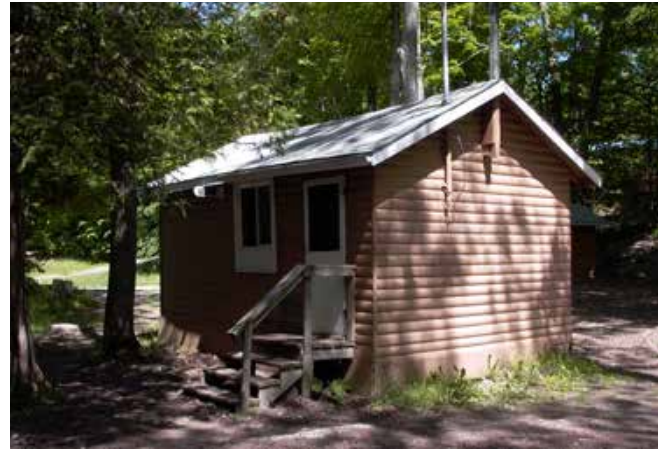
2. Huron Cabin

Walls and roof have a basic level of insulation, no vapour barrier present. Attic space venting at gable ends. Insulated plywood skirting has been removed. Older windows (slider) with screens. New entrance door - door has been relocated to south gable end - this opens onto a new entrance porch. This cabin contains personal storage boxes for users. Similar size and configuration as Algonquin, Iroquois, Ottawa. Painted wood siding in fair condition.

Fair to poor condition

Foundations: 6 - CMU piers on 18x18x3" concrete paver footings. Recommend reinforcing by installing additional pier and footing at mid span of centre 6x6 beam.

Floor: 2 - lines of 2x6 @ 16"c/c Floor Joists on 6x6 centre beam (short direction) and new 6x6 PT sill beams. Floor bouncy. Recommend reinforcing by installing new CMU pier and pad footing at mid-span of centre beam.

30 amps overhead electric services with a breaker panel. Electrical wiring is fairly new. No ventilation system. This cabin is under renovation at time of visit. Electric Heat, Smoke detector and Fire extinguisher.

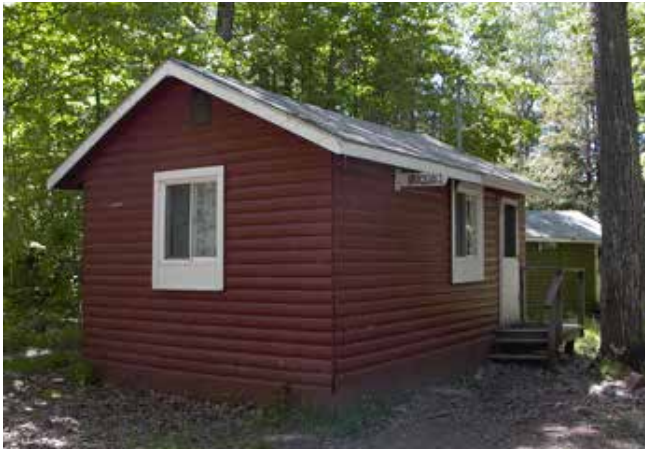
3. Iroquois Cabin

Walls and roof have a basic level of insulation, no vapour barrier present. Attic space venting at gable ends. Insulated plywood skirting has been removed. Older windows (slider) with screens. New entrance door and exterior casing. New entrance porch. This cabin contains personal storage boxes for users. Similar size and configuration as Algonquin, Huron, Ottawa. Painted wood siding in fair condition

Fair to poor condition

Foundations: 6 - CMU piers on 18x18x3" concrete paver footings. Recommend reinforcing by installing additional pier and footing at mid span of centre 6x6 beam.

Floor: 2 – lines of 2x6 @ 16"c/c Floor Joists on 6x6 centre beam (short direction) and new 6x6 PT sill beams. Floor bouncy. Recommend reinforcing by installing new CMU pier and pad footing at mid-span of centre beam.

30 amps overhead electric services with a breaker panel. No ventilation system. Electric Heat, Smoke detector and Fire extinguisher.

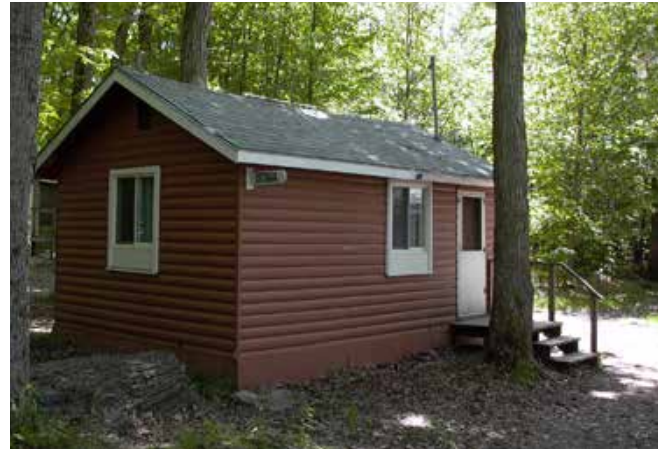
4. Ottawa Cabin

Walls and roof have a basic level of insulation, no vapour barrier present. Attic space venting at gable ends. Insulated plywood skirting has been removed. Older windows (slider) with screens. New entrance door - door has been reloacted to south gable end - this opens onto a new entrance porch. This cabin contains personal storage boxes for users. Similar size and configuration as Algonquin, Huron, Iroquois. Painted wood siding in fair condition

Fair to poor condition

Foundations: CMU piers on some concrete paver footings (not exposed to view). Like to recommend reinforcing by installing additional pier and footings as required.

Floor: Likely 2 – lines of 2x6 @ 16"c/c Floor Joists on centre beam (short direction). Floor bouncy. Recommend reinforcing by installing new CMU piers as noted above.

Porch: Older /poor condition.

30 amps overhead electric services with a breaker panel. No ventilation system. Electric Heat, Smoke detector and Fire extinguisher.

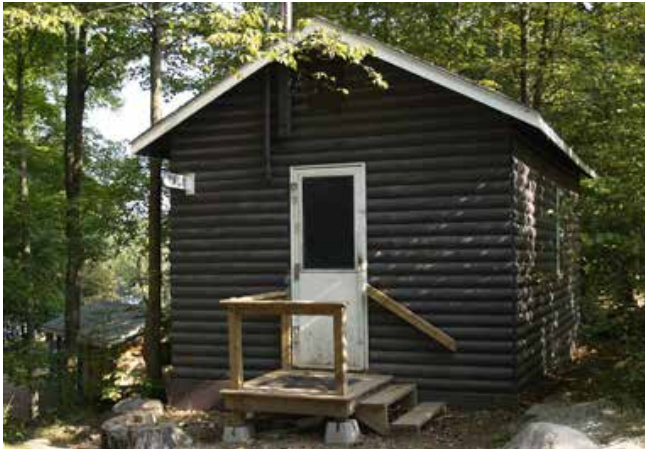
5. Mohawk Cabin

Walls and roof have a basic level of insulation, no vapour barrier present. Floor is not insulated. Attic space venting at gable ends. Plywood skirting around perimeter is insulated, but not venting properly, this has become potential nesting for rodents. Original single pane window (casement)) with screened storm window. Wooden door with storm/screen door. This cabin contains personal storage boxes for users. Similar size and configuration as Mississauga, Seneca, Siniwick. These 4 cabins have a more generous ceiling height than Cabins 1-4. Painted wood siding in fair condition

Fair condition.

Foundations: CMU piers on some concrete paver footings (not exposed to view). Like to recommend reinforcing by installing additional pier and footings as required.

Floor: Likely 2 – lines of 2x6 @ 16”c/c Floor Joists on centre beam (short direction). Floor bouncy. Recommend reinforcing by installing new CMU piers as noted above.

60 amps overhead electric services with a breaker panel. No ventilation system. Electric Heat, Smoke detector and Fire extinguisher.

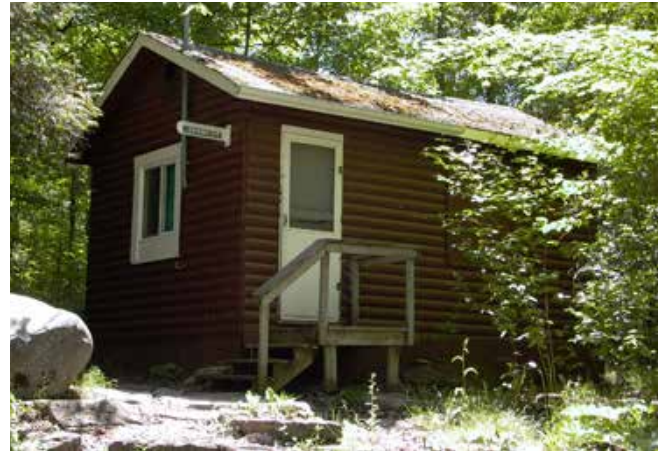
6. Mississauga Cabin

Walls and roof have a basic level of insulation, no vapour barrier present. Floor is not insulated. New metal roof, fascia and soffit. Trim to be completed at north gable end. Attic space venting at gable ends. Older windows (slider) with screens. Wooden door with storm/screen door. This cabin contains personal storage boxes for users. Bunks in this cabin have been built in and reinforced. Similar size and configuration as Mohawk, Seneca, Siniwick. These 4 cabins have a more generous ceiling height than Cabins 1-4. Painted wood siding in fair condition.

Fair to poor condition

Foundations: CMU piers on some concrete paver footings. Like to recommend reinforcing by installing additional pier and footings as required.

Floor: Likely 2 – lines of 2x6 @ 16”c/c Floor Joists on centre beam (short direction). Floor bouncy. Some upgrades to sill plate. Recommend reinforcing by installing new CMU piers as noted above.

Porch: Old/poor condition. REPLACE.

30 amps overhead electric services with a breaker panel. No ventilation system. Electric Heat, Smoke detector and Fire extinguisher.

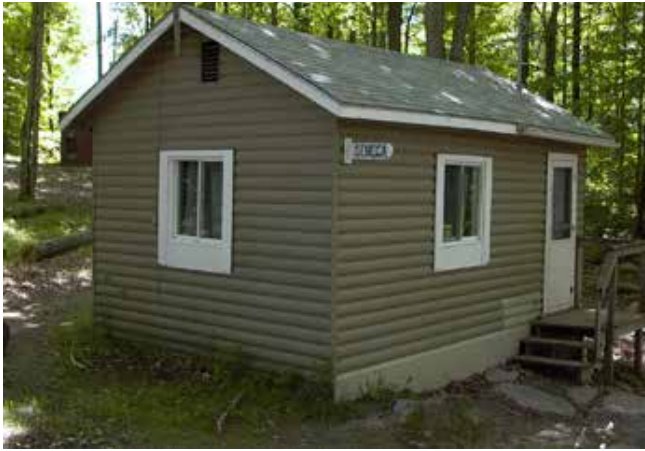
7. Seneca Cabin

Walls and roof have a basic level of insulation, no vapour barrier present. Floor is not insulated. Attic space venting at gable ends. Plywood skirting around perimeter is insulated, but not venting properly, this has become potential nesting for rodents. Older windows (slider) with screens. Wooden door with storm/screen door. This cabin contains personal storage boxes for users. Similar size and configuration as Mohawk, Mississauga, Siniwick. These 4 cabins have a more generous ceiling height than Cabins 1-4. Painted wood siding in fair condition.

Fair to poor condition

Foundations: CMU piers on some concrete paver footings (not exposed to view). Likely to recommend reinforcing by installing additional pier and footings as required.

Porch: Old/poor condition.

60 amps overhead electric services with a breaker panel. No ventilation system. Electric Heat, Smoke detector and Fire extinguisher.

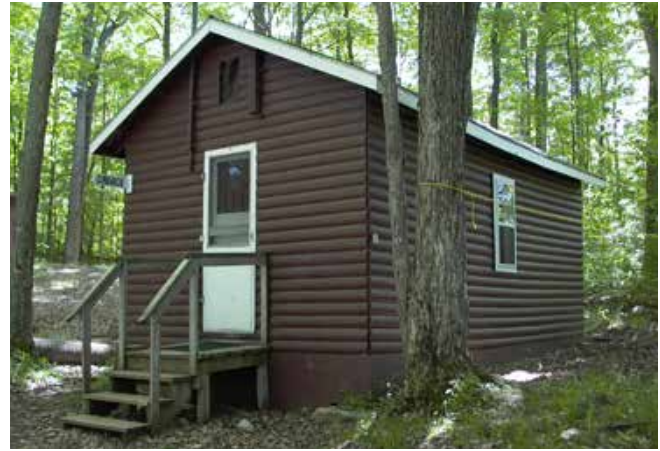
8. Siniwick Cabin

No access at time of visit, assumed to be similar to other Mohawk, Mississauga, Seneca cabins. Electric Heat, Smoke detector and Fire extinguisher.

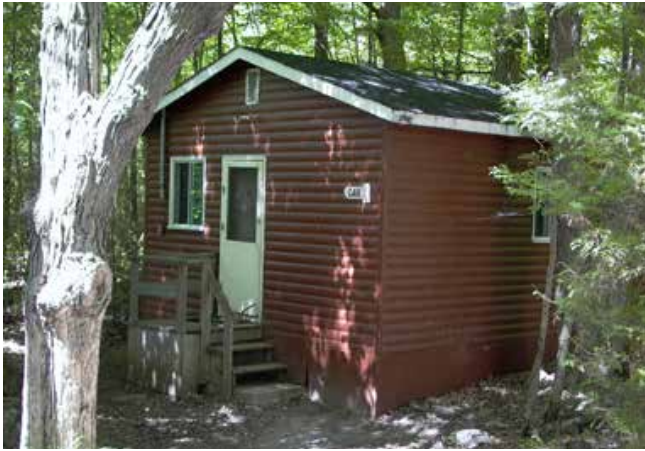
9. Oak Cabin

30 amps overhead electric services with a breaker panel. No ventilation system. Electric Heat, Smoke detector and Fire extinguisher.

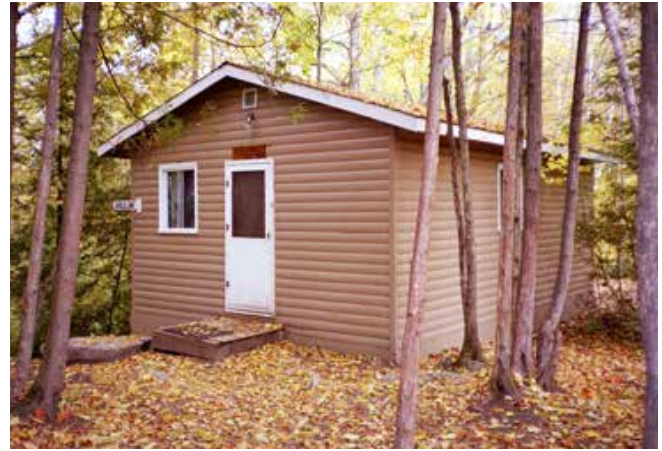
10. Willow Cabin

30 amps overhead electric services with a breaker panel. No ventilation system. Electric Heat, Smoke detector and Fire extinguisher.

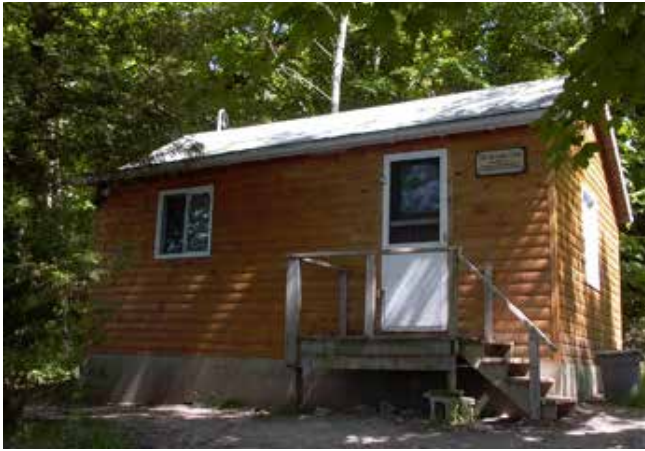
11. Spurway Cabin

60 amps overhead electric services with a breaker panel. Site lighting timer. No ventilation system. Electric Heat, Smoke detector and Fire extinguisher.

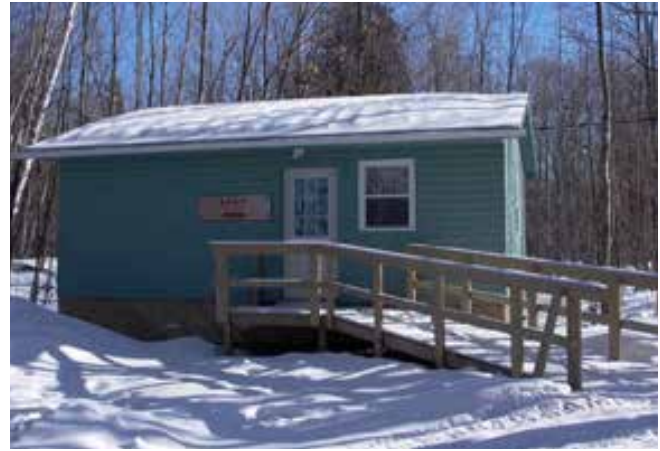
12. IODE Cabin

100 amps overhead electric services with a 32 circuits breaker panel. No ventilation system. Electric Heat, Smoke detector and Fire extinguisher.

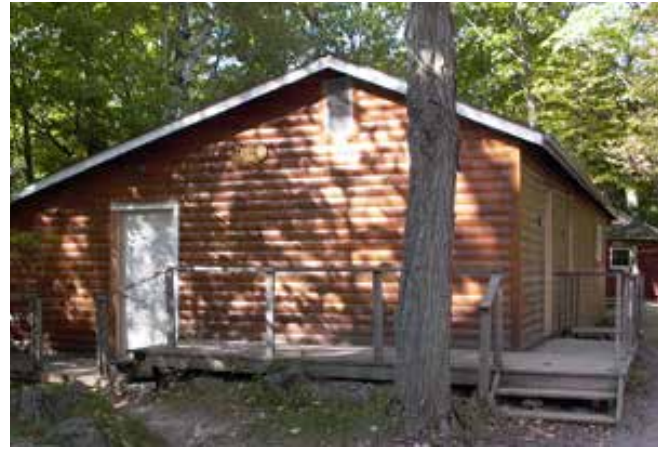
14. Jack Frost Centre (Long House)

The long house was built in two sections, the first part (1966) being the western half which faces the lake and houses educational displays, Arts and Crafts. The second part of the building (1986) is used for storage of recreational equipment. The floors of these two sections are at different heights to suit adjacent grading. Roof on original half of the building was replaced in 2006, good condition. No soffit visible, fascia is fair to poor condition. Stained wood siding in good condition. Building is not well insulated. Attic space venting at gable ends. Original single pane windows wood/aluminum and are either fixed or have sliders with screens. Entrance doors are wooden and Metal.

Generally in fair condition

Foundations: 14-16" sonotube piers appear to be in sound condition. There appears to be evidence of settlement along the centre line of the building where the craft room floor slopes to this line of bearing.

Floor: 2x8 @ 16" c/c Floor Joists on five 3 – 2x10 beams. As noted above – the floor/building is sloped to the centre line (wall between pre-existing and 1986 addition). Some rot damage to the sill/rim joist of the original building in several locations.

Porch: The rear covered porch is founded on CMU foundations with PT lumber blocking.

100 amps overhead electric services with a 30 amps breaker panel. Electric baseboard heaters. No ventilation system.

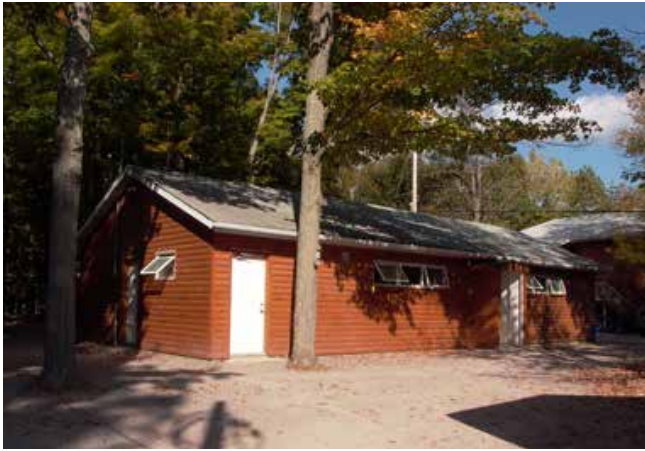
15. Washroom Building (Colosso)

Roof - shingles, good condition, insulated with batts. Windows - vinyl good condition (awnings). Stained wood siding in good condition. Floor - slab on grade, blown-in insulation within walls. 4 showers for each gender, (1 of 4 are accessible). 5 toilets for each gender, (1 of 5 are accessible). Recently upgraded shower finishes and partitions. Double wall down centre of the building for servicing.

Foundations: Concrete slab on grade in good condition. Possible slab thickening at edges to support load bearing walls above.

Roof: Clear spanning roof trusses in good condition.

200 amps overhead electric services with a breaker panel. A 1,300 gallon reservoir tank with circulating pump & well tank is provided for the treated domestic water system. The domestic water pipe is tied back to the kitchen dining room system in the other building. The water treatment system consisted of UV lamps, chlorine tank with injector, water filters and pressure tank. The sewer is connected into the septic system. Exhaust fans is provided in each washroom. Humistat. Three (3) 60 gallon electric hot water tank with 4.5 KW heating element.

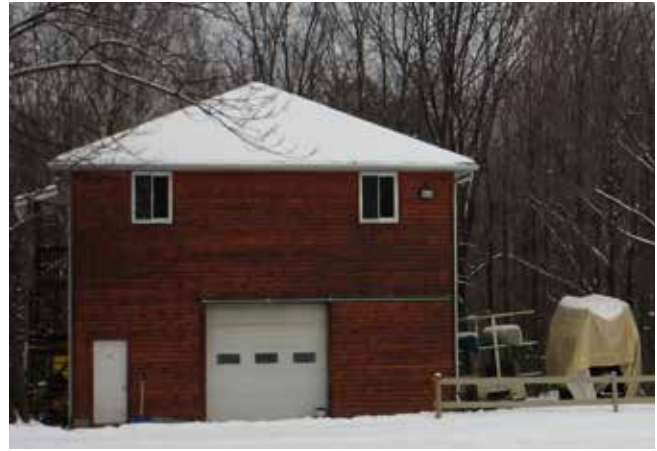
16. Comstock Learning Centre (Hangar/Workshop)

Two storey buildings, approximately 12' ground floor ceiling height with a clear span for the second floor structure and a garage door opening towards the playing field. Lower level is used as maintenance shop and materials and equipment storage, upper level is used as classroom space. 2x6 framing with R20 insulation. Original roof in good condition. Fire rating between ground floor and second floor. Poor acoustic separation between ground floor and second floor. Stained wood siding in good condition. Vinyl windows and metal doors in good condition.

Foundations: Founded on 8" CMU block foundation walls – presumably on concrete strip footings. Good condition.

Floor: Workshop ("Hangar") slab on grade in fair condition with some shrinkage cracking with little to no (1/8" max) differential settlement.

Second level framing is clear spanning – which may be wood floor trusses or beams and wood joist infill. Floor feels very solid and in good condition.

Roof: Likely roof trusses. No apparent sagging and roof appears to be in good condition.

Porch: Stairs and cantilevered entry deck in good condition.

General: Built – early '90s. Sound structural condition.

A 200 amps panel is located in the workshop, this panel feeds power Gainey, Estate and the Log Cabin. Electric heaters is located on the second floor only. There is no permanent heater installed on the ground floor, construction heaters used during winter month. No ventilation system. No water supply or bathrooms.

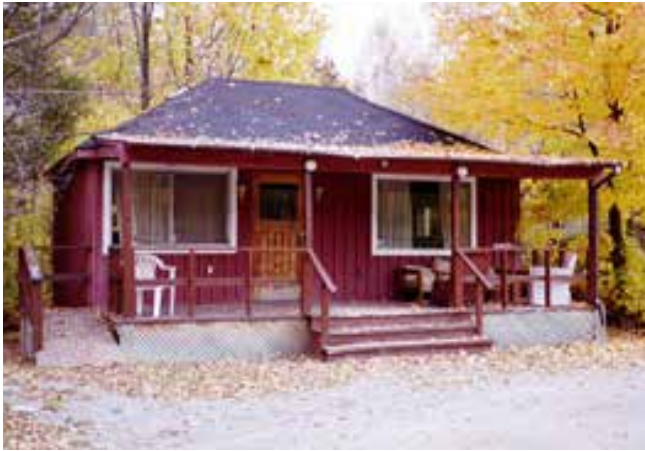
17. Estate Cabin

Wheelchair accessible, 2 room building. Shingled Roof on main building - 2 years old, periodic water penetration issues, corrugated roof over porch, poorly joined to main roof. Walls, roof and floor have a basic level of insulation, no vapour barrier present. Attic space venting through a button vent on roof top. Original single pane windows (slider on west room, fixed in east) with screened storm window. Newer steel Entrance door. This cabin contains personal storage boxes for users. Painted wood siding in fair condition. Fair condition

Foundations: Founded on CMU piers on concrete paver footings. Porch framing is founded on timber footings.

Floor: Slightly bouncy. Likely 2x8 joists. Porch in decent condition. Verandah roof is supported on posts on porch rim joists that are deflecting as there is no footing below these bearing points.

Porch: Wheelchair accessible. Good condition.

General: Decent condition. Good surface drainage makes timber foundations feasible short term.

100 amps underground services is fed from the Learning Centre. This service is surfed to Greenhouse and Trading Post, 60 amps each. Electric Heat, Smoke detector and Fire extinguisher.

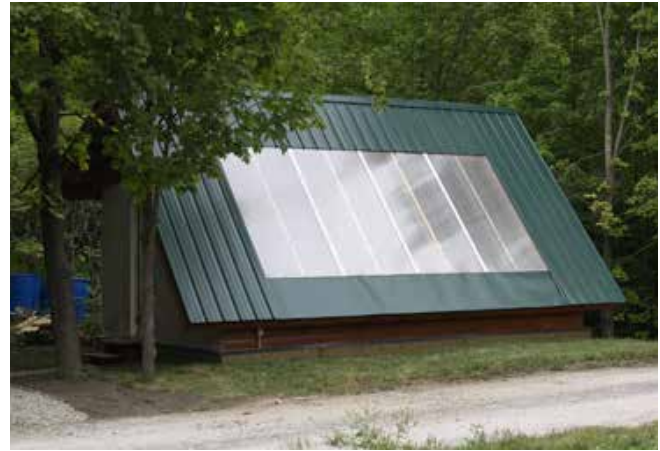
18. Greenhouse

Strawbale +/- R40 (14"-16" thick walls). Metal roof in good condition. Windows - polycarbonate south facing - not operable, small operable vinyl window above entrance door. Standard insulated steel entrance, not well sealing within frame. Insulated Slab on grade. High humidity levels could pose an issue to indoor air quality - appears to be affecting the interior finish of the straw bale walls. Generally good condition, except for humidity/air leakage issues. Address humidity levels or protection of interior materials.

Foundations: Frost protected slab on grade. Slab thickens at edges below load bearing walls above.

Floor: Slab on grade in good condition.

Walls: Three walls constructed of 14" load-bearing straw bale with plaster finish (total assembly @ 16"). Wood stud pony wall below green roof. All in good condition although straw bale walls are susceptible to mold due to poor ventilation.

General: Built - 2005. Sound structural condition.

8 circuits 60 amps panel is installed fed from underground service. Portable electric heater. General lighting with ceiling fan. No outdoor ventilation, no humidity control, no drain. Humidity level is quite high at time of visit.

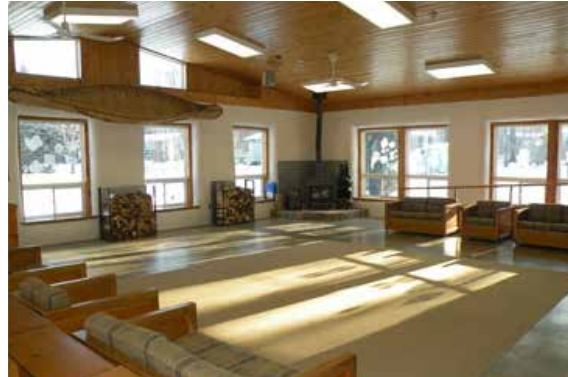
Rotary Hall

Foundations Rotary Hall: Likely constructed on thickened slab

on grade edge or frost protected foundation walls on strip footings.

Floor RH: Slab on grade in good condition.

Walls RH: 14" Straw bale walls with ½" plaster in good condition. Some shrinkage cracking in plaster noted.

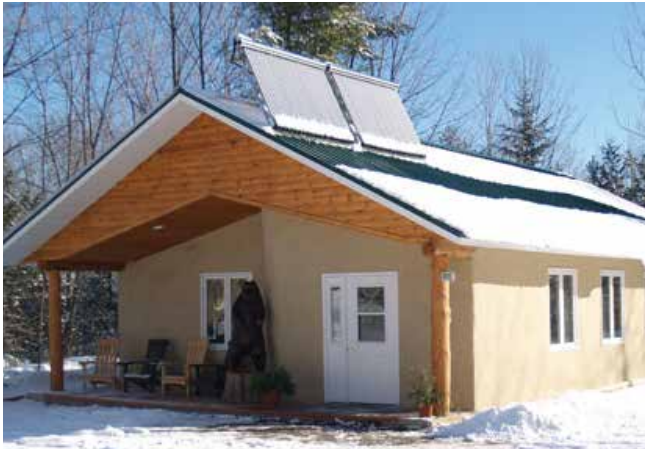
22. Main Office

Straw bale construction with plaster finish. Generally in good condition, a few cracks in the south east corner of the building. The building is well insulated wall and roof assemblies (+/-R40). Metal roof in good condition, soffits are a combination of wood and perforated metal. Newer vinyl windows and new insulated steel entrance door. Radiant system in slab which is supported by solar collectors on roof. Generally very good condition

Foundations: Frost protected slab on grade. Slab thickens at edges below load bearing walls above.

Floor: Slab on grade in good condition.

Walls: Walls are constructed of 14" infill straw bale with plaster finish (total assembly @ 16"). Bales infill wood post and beam construction. Some significant cracking of interior finishes occurs in the rear of the building around window openings. These do not appear to be structural in nature but are in our opinion due to shrinkage.

Roof: Scissor trusses in good condition.

Evacuated type solar panel is installed coupled with a in-slab hydronic heating system equipment with circulating pump. System is not in operation at time of visit. Potable electric heaters was plugged in as primary heating at time of visit. Domestic water is supplied to this building from the washroom building. Washroom facility is provided for this building. Sanitary sump pump is installed to pump the sewage back to the distribution box for the septic system. There is no ventilation system installed in this building other than ceiling fans. Emergency lighting & smoke alarm detectors is installed.

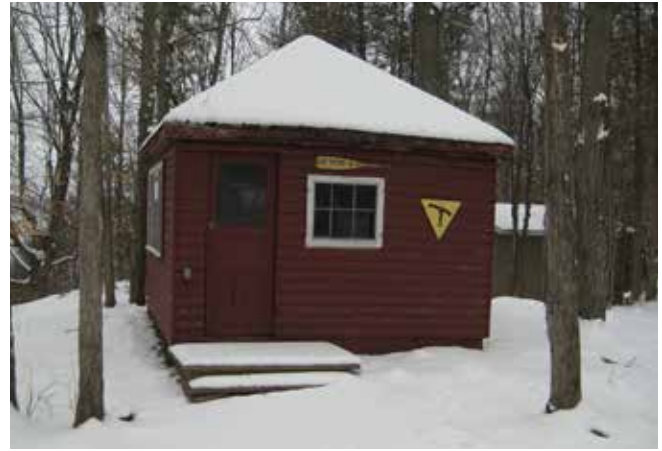
35. Cedar - Trip Storage

This building requires immediate review and structural remediation.
